## Long-term deterioration of material properties of 3M Scotchkote spray liner products

The following fact sheet gives the results of tensile and flexural tests conducted on two 3M spray liner products: Scotchkote 269 and Scotchkote 2400, installed in 2009 and 2015 respectively, which were removed from in-service pipes.

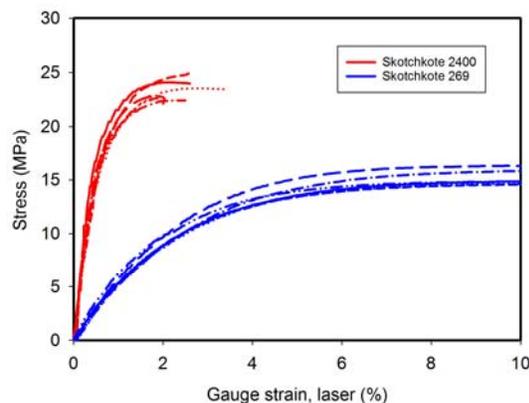
Figure 3: Tensile test results for two ex-service 3M spray liners

A decrease in tensile strengths of both liner products were observed compared with original values. The flexural strength of the Skotchkote 269 liner however appears not to have changed significantly, although the 2400 liner shows a decrease in its flexural strength. The possibility of water, chlorine or internal pressure leading to strength degradation needs to be evaluated based on this data.

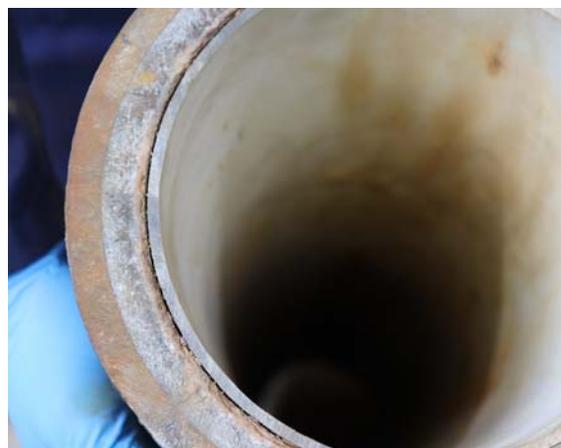
The older liner (269) showed signs of de-bonding from the host pipe (Figure 5), which could have occurred with time and deterioration of the liner material or due to external factors such as water intrusion. This needs to be investigated further.

Figure 5: De-bonding of liner and corrosion products between liner and cement liner (Skotchkote 269)
