Pipe bending rig trial tests

This fact sheet provides information on initial pipe bending tests performed using the Monash University full-scale pipe bending rig. The test setup and working principles are briefly explained and future tests are outlined.

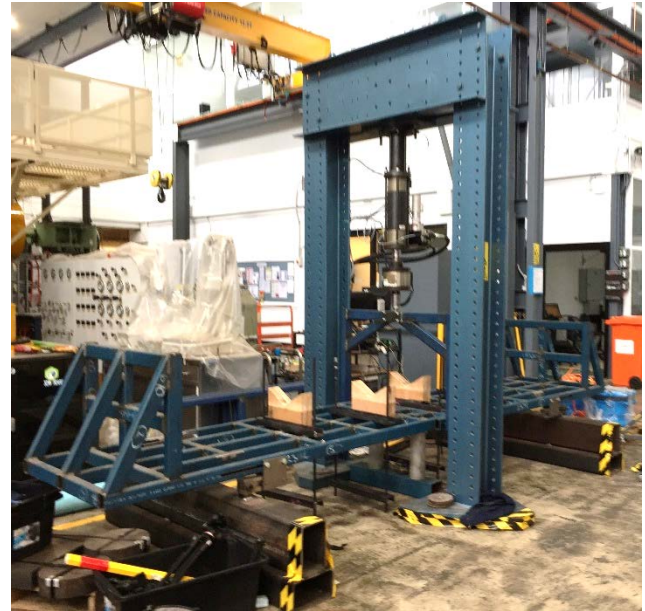
Pipe bend tests can be conducted on pipes with diameters of up to 300 mm (DN300). The testing will be conducted under 4-point bending, using clamps to attach the pipe at 4 locations to the bending platform. Testing is displacement controlled (2-10 mm/sec). This test was devised to examine whether the liner will survive a bending failure (broken back). The idea of this test is to see whether the liner will detach from the host pipe when the host pipe fails and whether the liner is still intact. This test will also check whether the whole liner detaches or just a certain section of the liner. For this to occur, adhesion of the liner to the host pipe must be low enough to debond near the break (so that the liner does not experience infinite strain and crack), without affecting exposed sections of liner, such as tappings or fittings.

Figure 1: Pipe bending rig with clamps and supports

The results will depend upon the longitudinal strain the liner can exhibit and the bonding strength of the liner. Testing will involve unpressurised and pressurised pipe samples. Tests can also be conducted on joints if a joint is present. The failure case for CIPP and spray liners for the pipe break tests will be due to bending and tension. The bending rig setup is shown in Figure 1.

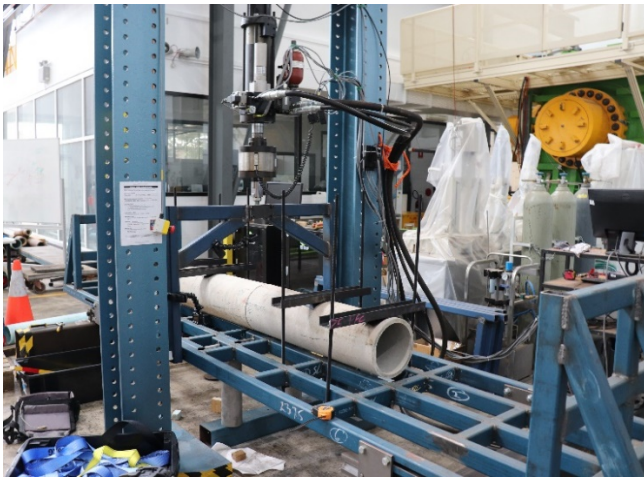
Trial 2 was conducted with stiffer metal clamps. The test was conducted on an FRC pipe with a joint in the

center. The pipe showed considerable bending before failing at the joint. The joint mainly moved out of the socket as the pipe rotated. Crushing at the top of the joint was the failure mechanism. Also, the platform the pipe was laid allowed the pipe to rotate more on one side, therefore it was suggested to use mounting supports for the next test. The test setup used for Trial 2 is shown in Figure 2.

Figure 2: Test setup for trial 2, showing the use of metal clamps on an FRC pipe

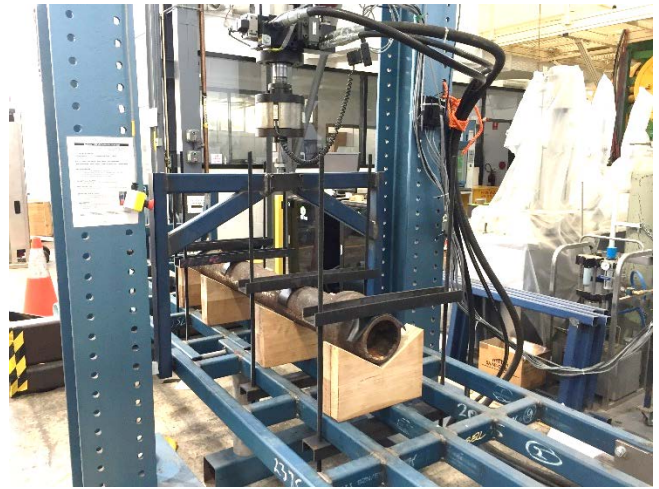
Trial 3 was conducted on a cast iron pipe with a joint at the end. Wooden supports were used to elevate the pipe to maintain the pipe horizontal due to its joint. Such supports would also be used to elevate pressurised pipes with end caps.

Figure 3: Test setup for trial 3 with wooden supports and metal clamps.

The cast iron pipe (DN 125) tested in Trial 3 failed by a broken back (circumferential failure) between the mid-point of the pipe and one of the close supports (Figure 3). Manufacturing defects were visible at the crack from post failure analysis in the old pit-cast, cast iron pipe. This test proved successful and for future tests on newer pipes lined with polymer liners artificial defects may need to be introduced. Figure 3 shows the testing setup for the cast iron pipe.

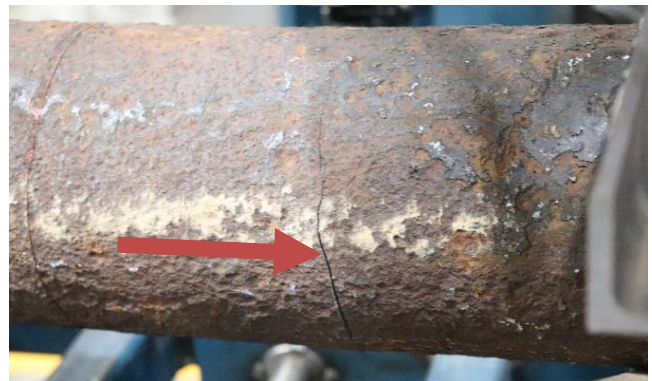
Figure 4: Broken back failure in Trial 3, CI/CL DN125 pipe.
