**Survey and Review of Current Rehabilitation and Coating Technologies for
Many Entry Sewer Pipes and Manholes with Protective Coatings**

Part 2: COATING PERFORMANCE

Date: 2nd December 2011

Author: Marjorie Valix

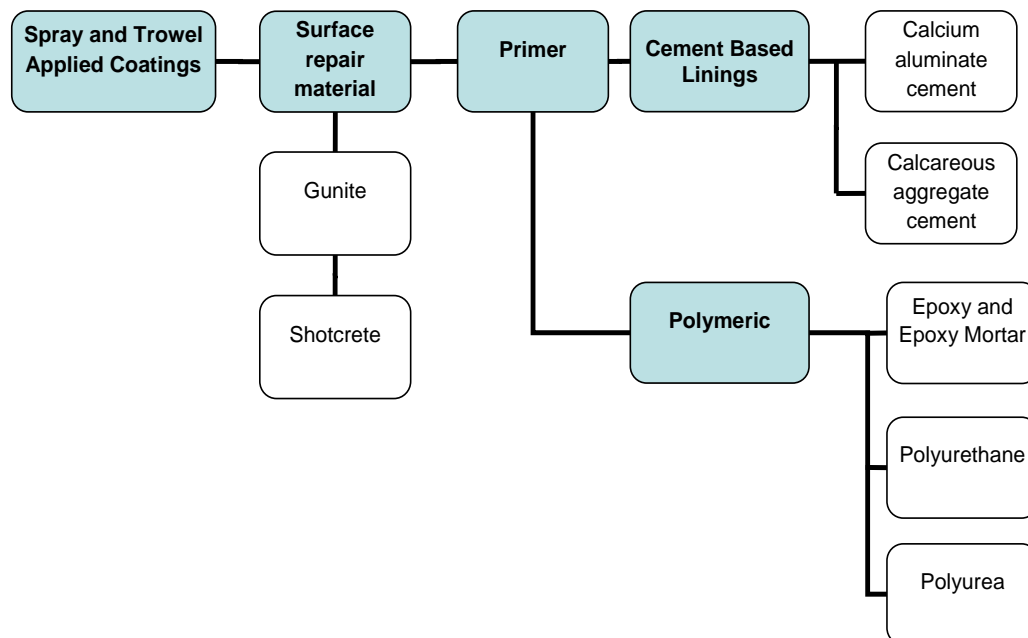
Figure 1. Spray and trowel applied coatings technologies for sewer protection

The linings that are used in protecting sewer pipes and related infra-structure are either cement or polymer based. Figure 1 shows the basic spray-on and/or trowelled applied coating technologies available today, including the surface repair material and primer that are often used in preparing the surface of the substrate prior to coating application. The use of surface repair and primer are optional (Sunarho 2012). In certain cases these may not be required or the industry may simply choose not to use them.

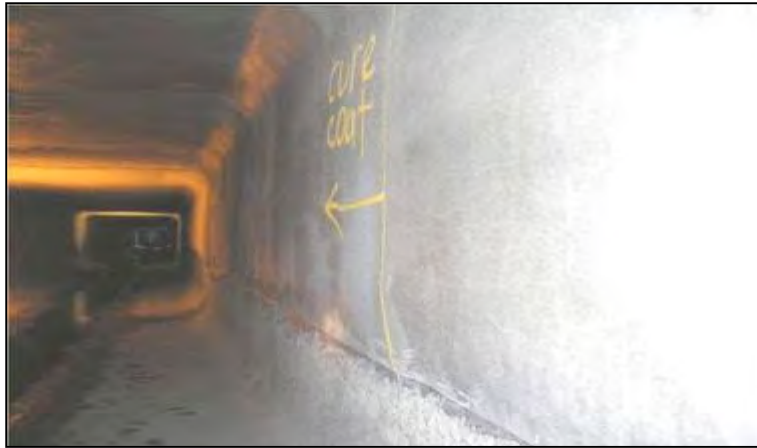
Figure 2. CAC Application Trial in SWSOOS 2007, SW showing minor crazing after 18-19 years of service, otherwise intact and in good conditions.

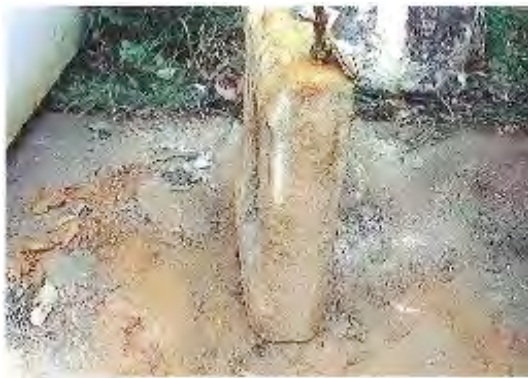
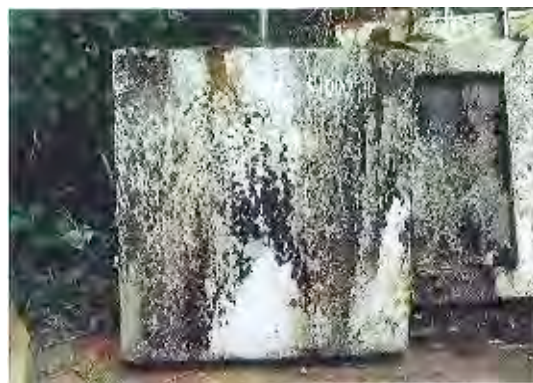
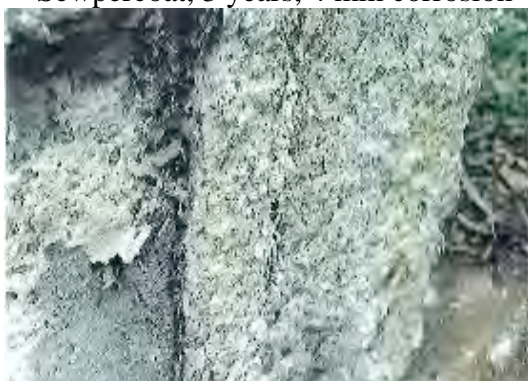
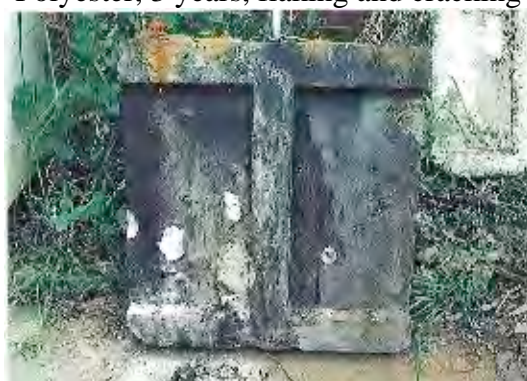
Sewpercoat, 3 years, 4 mm corrosion

Polyester, 3 years, flaking and cracking

Water impermeable membrane, 3 years, 15 mm corrosion

Epoxy coal tar, 3 years, blister, 10 mm concrete corrosion

Figure 3. Comparison of performance of coating systems in Melbourne Spotswood North Drop structure (Wubben 1999).

Melbourne Water performed trial testing of Sewpercoat (100% CAC or 40% Al₂O₃) and Sewperspray (16% Al₂O₃) in 1995, supplied by then by Lafarge, to combat the rising corrosivity of the gas in its sewer (Wubben, 1999). Blocks of type D sulphate resistant concrete coated with CAC were installed in Melbourne Water Spotswood North Drop structure. This site is particularly aggressive with H₂S content of 25ppm in winter and 65 ppm in summer in addition to the chemical cocktail of domestic and industrial discharges. The performance of two types of CAC were compared with an experimental alternative mortar, UHB epoxy, vinyl ester, epoxy coal tar and water impermeable membrane (see Figure 3). Concrete blocks coated with water impermeable membrane showed 15 mm corrosion in 3 years and coal tar epoxy (0.5-1.0 mm) showed blistering in 18 months, which subsequently increased in occurrence and some bursts by 3 years resulting in 10 mm of concrete deterioration. Alternative experimental mortar also failed in 3 years. One of the UHB epoxy failed after 18 months, polyester failed in 3 years, the remaining UHB epoxy and vinyl esters were in satisfactory condition in 3 years. Sewpercoat and Sewperspray that were applied with 30 mm thickness showed minimal deterioration in 3 years. Sewpercoat deteriorated by 2mm and Sewperspray by 4 mm.

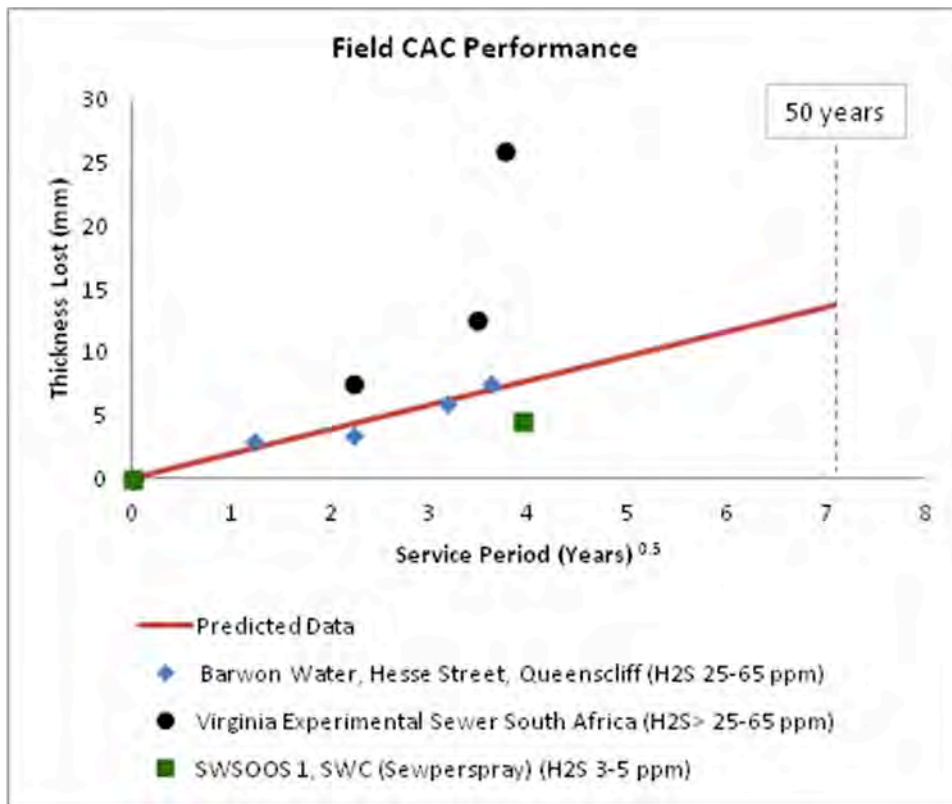
Figure 4. CAC current and predicted performance in Barwon Water (Hesse St, Queenscliff) (Wubben. 2008), Virginia Experimental Sewer, South Africa and SWSOOS 1, SWC. (Note thickness measurements in Barwon Waters were corrected for expansion of CAC e.g. actual thickness loss of 20-40 mm is equivalent to 4-8 mm. Measurements were confirmed by actual remaining thickness left).

A parallel trial of Sewpercoat was carried out by Barwon Water (Wubben. 2008). The Corcon 2008 report on Sewpercoat CAC performance in Barwon water covered 13 years of service life (Wubben, 2008). The loss of thickness over this period is shown in Figure 4. Superimposed on this correlation is the prediction of over 50 years, assuming the loss of thickness over this period is dependent only on diffusion. The predictive model was determined and fitted to the thickness loss (x) and period of service (t) to the equation $x = k t^{0.5}$ with an R² of 0.96. It appears based on this prediction than in 10 years only 13.7 mm of the coating would be lost. That is 50 mm thick CAC would be able to provide protection over the 50 years service life of the

coating. Similar field test result from Virginia experimental sewer in South Africa (Goyns 2008) and in SWSOOS1, SW are included in Figure 4. The lower CAC thickness loss in SWSOOS 1 and higher loss in Virginia sewers are consistent with the H₂S concentrations in these sites. SWSOOS1 typically has between 3-5 ppm of H₂S and although Virginia sewer conditions were not reported, the higher material loss suggest the H₂S here is > than 25-65 ppm experienced in Barwon Water. At the Virginia site, OPC was corroding 4 times faster than CAC at the rate of 7.5 mm/yr. The two interesting features of these results are one the early performance of CAC in SW and Virginia sewer and their close fit to the low rate of material loss in Barwon Water. This suggests that CAC could reasonably provide adequate protection within 12-13 years when H₂S concentrations are at least below 65 ppm. The later performance, particularly in Virginia shows rapid corrosion, indicative of the challenge in using early data to predict the long term performance of CAC. The rapid

corrosion is attributed to CAC conversion. The conversion of CAC, which is inevitable, converts its mineralogy to the more reactive phase.
